# Technical Service Bulletin

**Cobra Motorcycle Mfg.**

## TSB0504: 2004 King & CM50 water pump drive belt & pulley alignment & inspection.

April 2, 2004

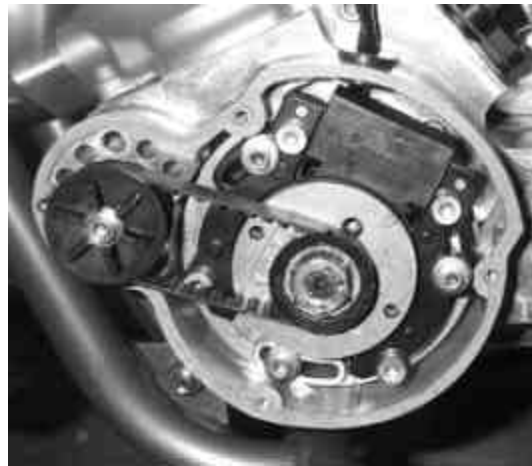
It is important to inspect three things on the water pump drive pulley and belt.

Inspect

1. That the belt and pulleys are in proper alignment and that the belt is not rubbing on flywheel or edges of the pulleys
2. That the pulleys are not cracked
3. That the water pump impeller pulley fastener is tight and has adequate high strength thread lock agent applied.

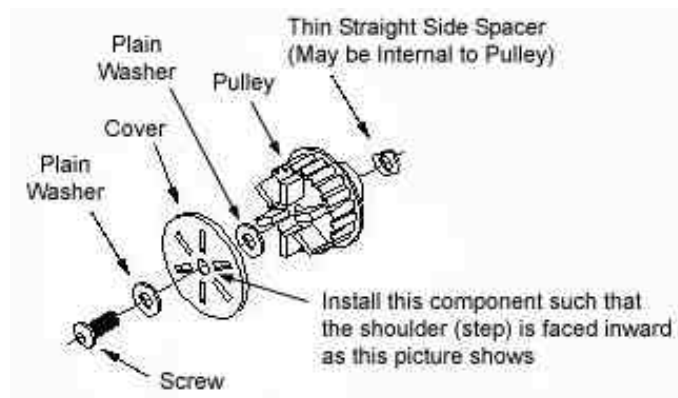
Below is the proper orientation of the water pump drive pulley, cover, and spacers.
