Technical Service Bulletin

Cobra Motorcycle Mfg.

TSB1004: 2004 King & CM 50 engine case screws

April 2, 2004

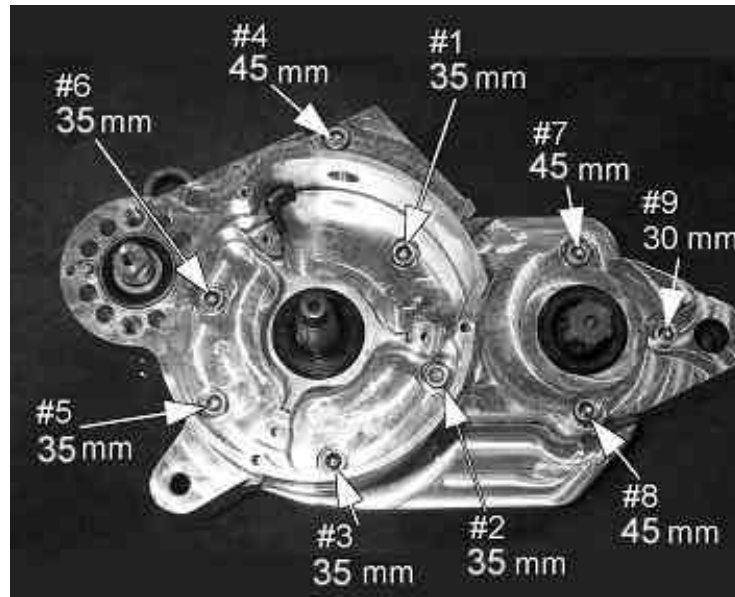
If these screws become loose the machine could experience an air leak and/or an oil leak.

During new product break-in check the tightness of the engine case screws.

Proper torque is 80 in-lb (9 Nm).
