Technical Service Bulletin

Cobra Motorcycle Mfg.

TSB1104: 2004 King kick lever set screw

April 2, 2004

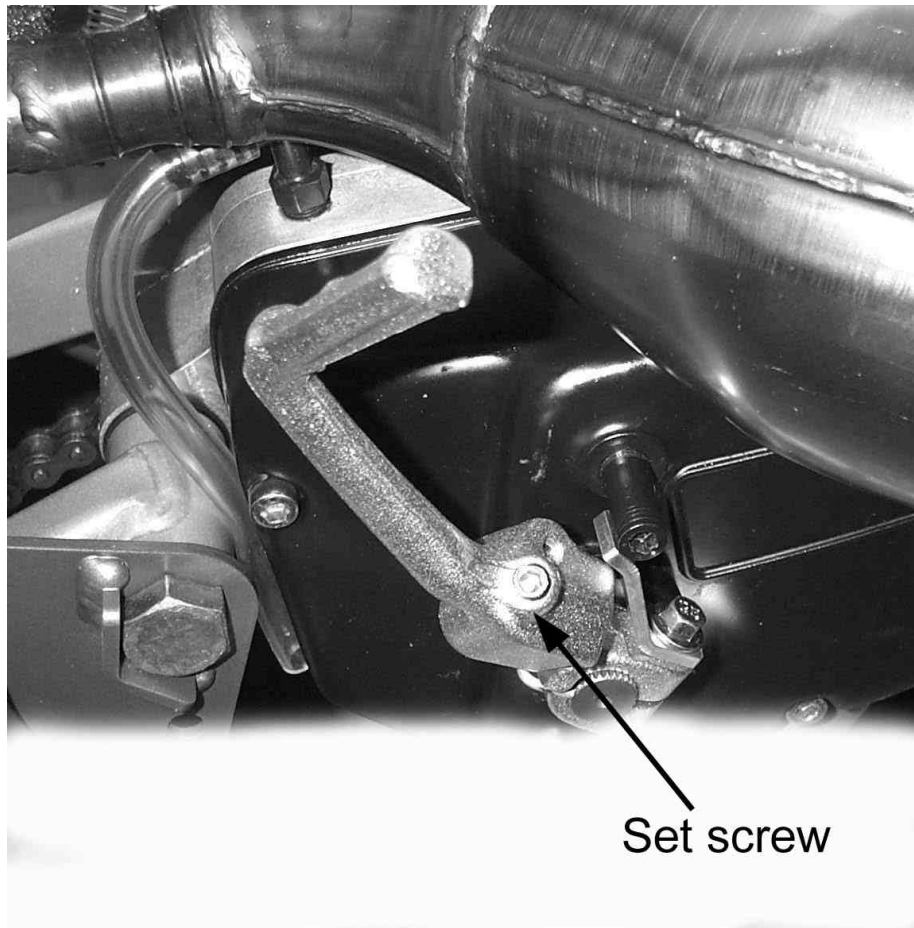
The setscrew on the 2004 King 50 can vibrate out. This can allow the spring and detent ball to become lost.

It is advisable to install some thread locking agent to the threads of the set screw when it is adjusted to the desired setting (set screw positioning in and out determines the ease with which the kick lever can be rotate into position).

Cobra has replacement ball, spring, set screw kits available if necessary.
